National Park Service
Cultural Landscapes Inventory

Appalachian Trail - Central District
Shenandoah National Park

Inventory Unit Description:

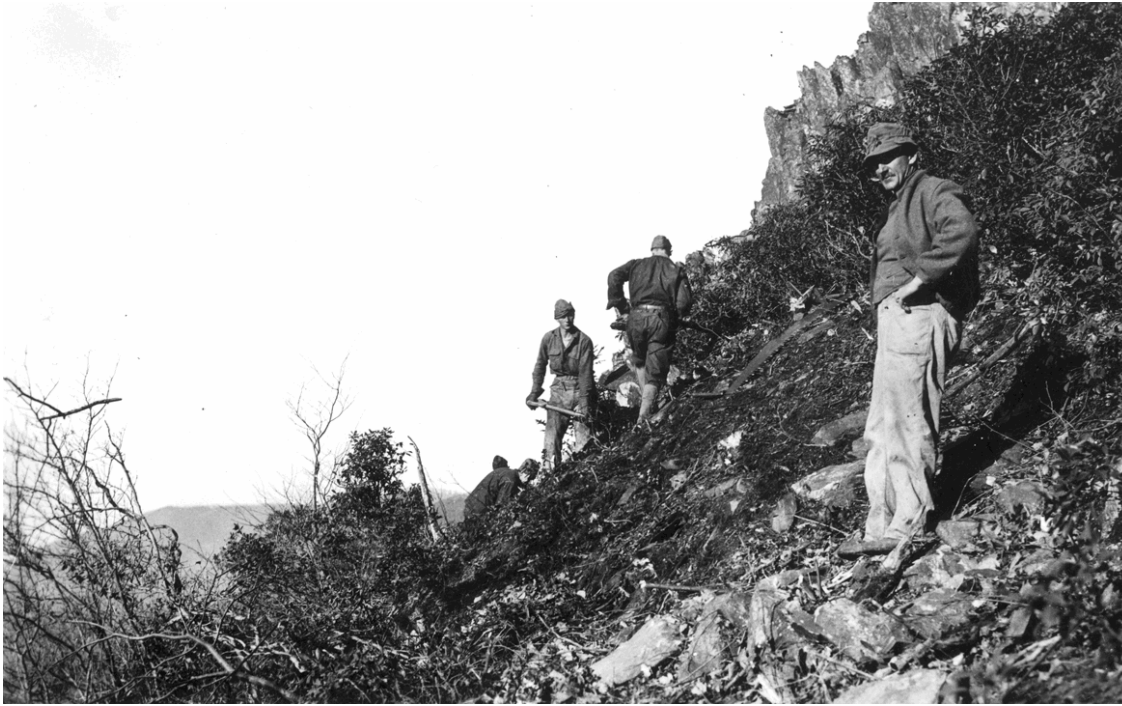
Figure 4: Civilian Conservation Corps (CCC) photo shows men conducting preliminary work on the AT south of Crescent Rock. The trail bed was built out from the steep slope to support the trail circa 1935. (Shenandoah NP Archives)

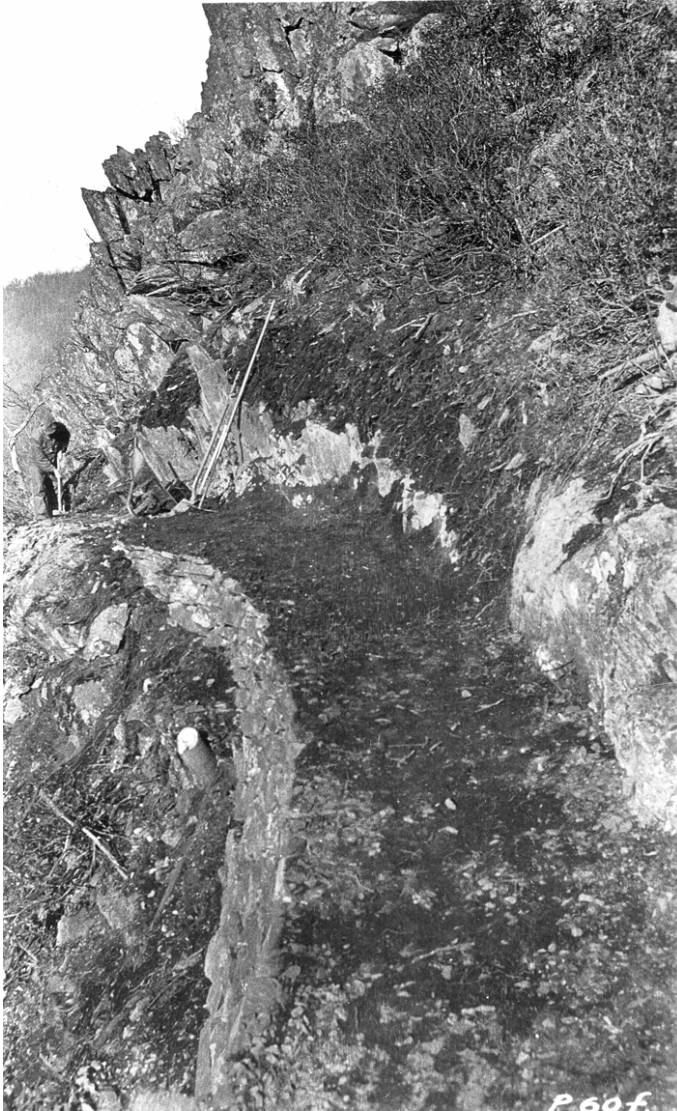
Figure 5: Mid-construction of the AT south of Crescent Rock. The trail bed was cut out of the slope and built up from below with retaining walls. (Shenandoah NP Archives)

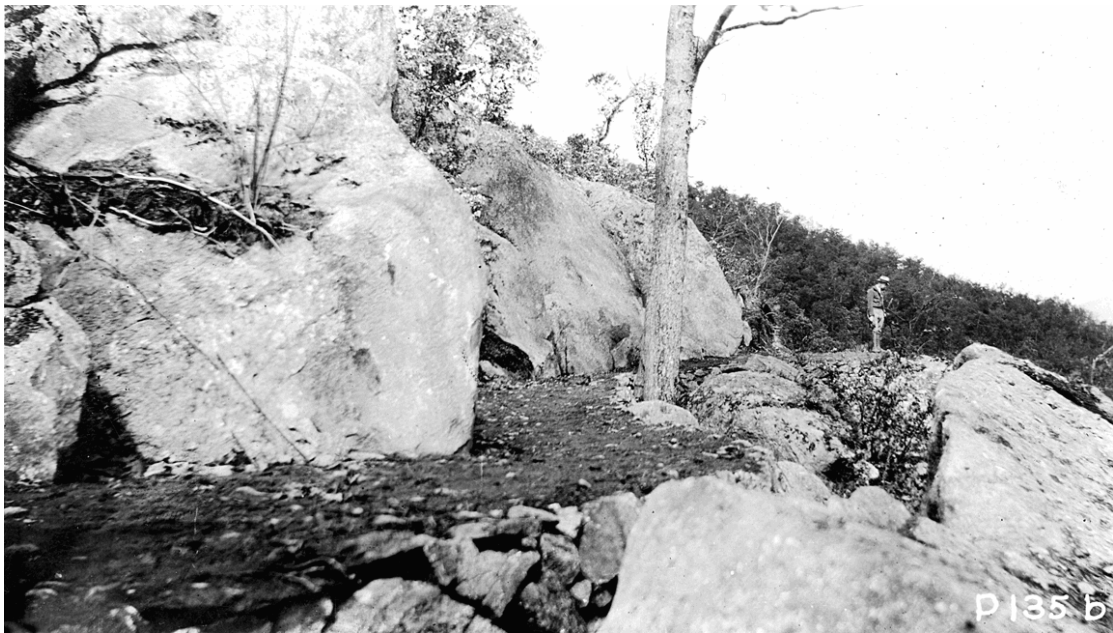
Figure 7: CCC photo showing completed AT to Mary's Rock circa 1935. The trail engages the topography and winds among the rock outcrops. The trail bed is supported by stone edging and low retaining walls. (Shenandoah NP Archives)

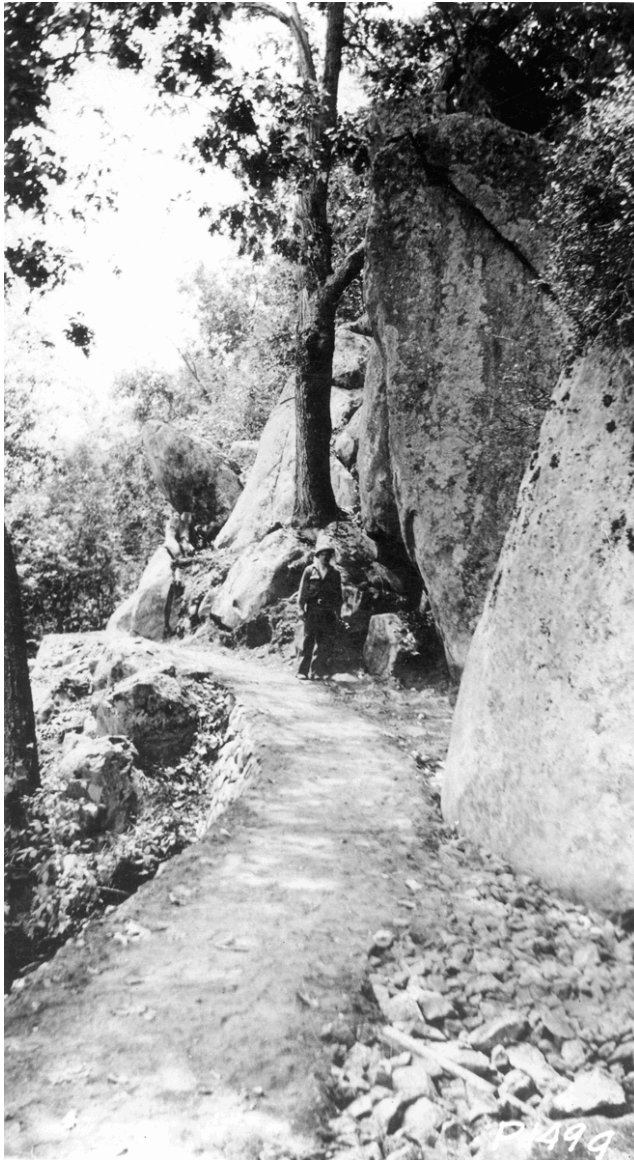
Figure 8: CCC photo showing completed AT to Mary's Rock, circa 1935. The trail has a width of 42-48 inches, is surfaced with gravel, and is supported by a stone retaining wall. (Shenandoah NP Archives)

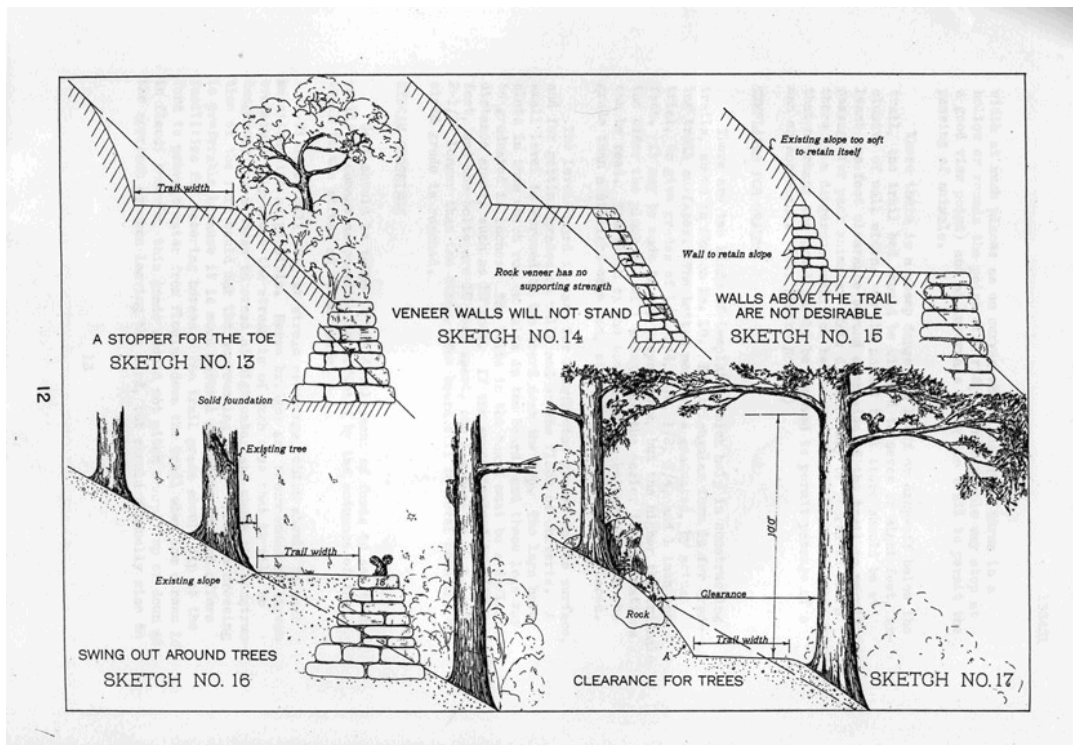
Figure 10: The 1937 manual, *Construction of Trails*, shows proper construction of retaining walls around trees, dissuades use of walls above the trail, and suggests a 10-foot clearance for horses. (Shenandoah NP Archives)

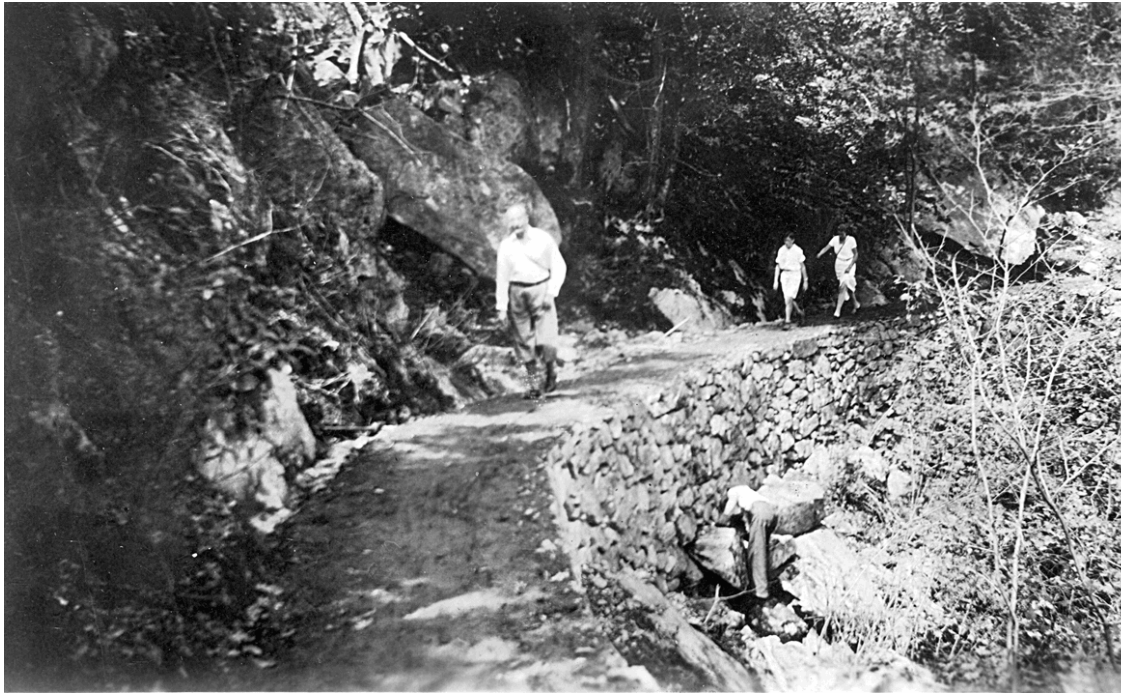
Figure 11: CCC photo showing the AT to Mary's Rock, circa 1935, and a large stone retaining that supports a trail bed built out from the steep slope. Both the trail and wall display a graceful sweeping curve. (Shenandoah NP Archives)

“Rubble masonry may be laid coursed or uncoursed....Most of the low retaining walls, slope walls, and miscellaneous structures in park projects are laid up in rubble masonry. It fits into the surroundings better than more formal kinds of masonry, and is usually built of stones found nearby. For these projects, it is the most attractive masonry when well built, and satisfies all of the requirements of such field structures. More than that, rubble masonry is a thing of beauty when well done, and its composition and pattern call for good judgment and imagination... Rubble masonry is one of the best things that an enrollee (CCC) can learn to handle, for experts in this trade are in demand, and architects and landscape architects always have need of men who can lay up this type of masonry in an artistic manner. The thing we find most beautiful is that which satisfies our sense of proportion and of suitability of materials, and our feeling of good taste in design. It will be simple and appropriate, in a pattern pleasing in its variety and balance, and having unity with its surroundings.” (USDI, Brick and Stone Work ,1937:9,11) (Fig. 11).

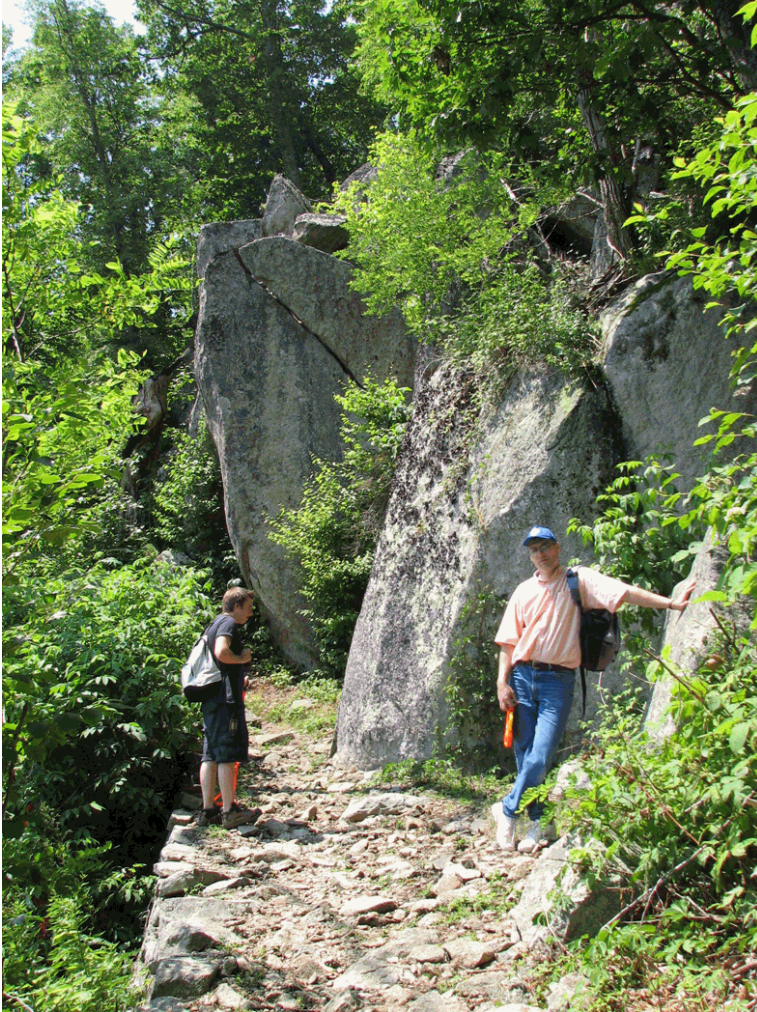
Figure 13: The Construction of Trails manual recommended selecting routes that passed rock outcrops to display local geological history. This section of the AT to Mary's Rock required a retaining wall to support the treadway. (SUNY, 2006)

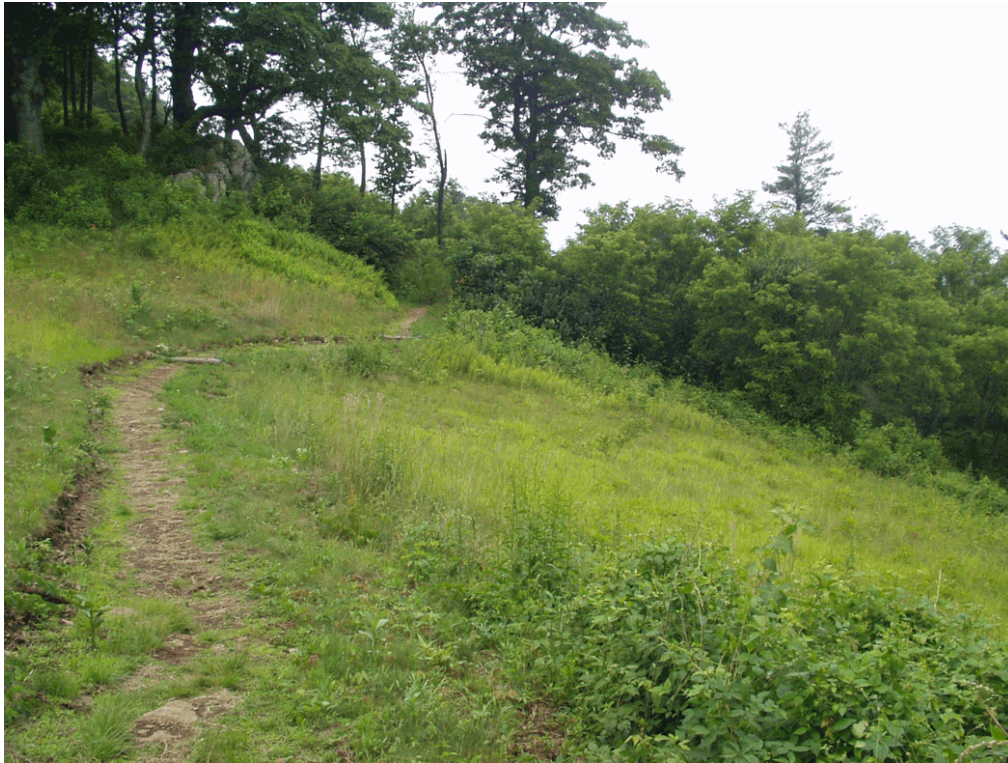
Figure 15: The AT opens just below Jewel Hollow Overlook providing a distinct change in the trail's character, from enclosed to open. (SUNY, 2006)

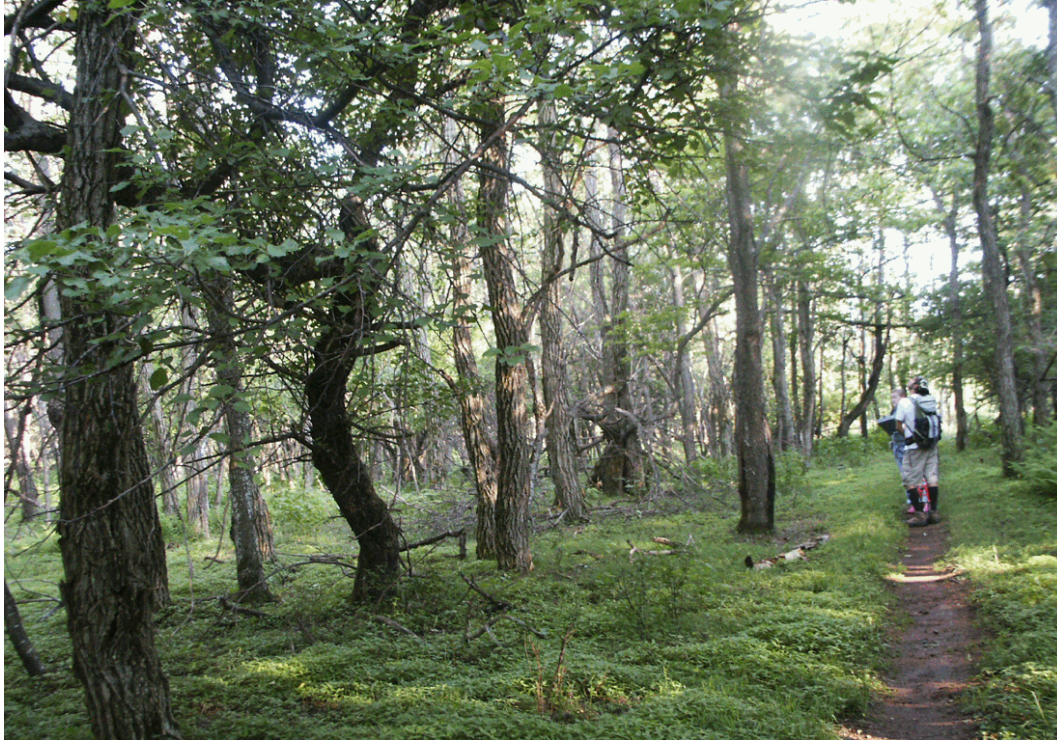
Figure 16: The AT passes through old orchards which tell of past agricultural land use such as this section near Tanner's Ridge Road. (SUNY, 2006)

Since 1942, the AT has continued to serve as a recreational trail for the hiker whether trekking on a through-hike from Georgia to Maine or hiking smaller segments of the trail and associated side trails. Traces of old farmsteads are disappearing, but are still revealed in extant wolf trees in old farm fields or in remnant orchards that the trail passes through (Fig. 16). The limits of old fields can also be discerned by the age of the woods. The AT–Central District is no longer a multi-purpose trail as horse riding is excluded as well as bicycles and other wheeled vehicles.

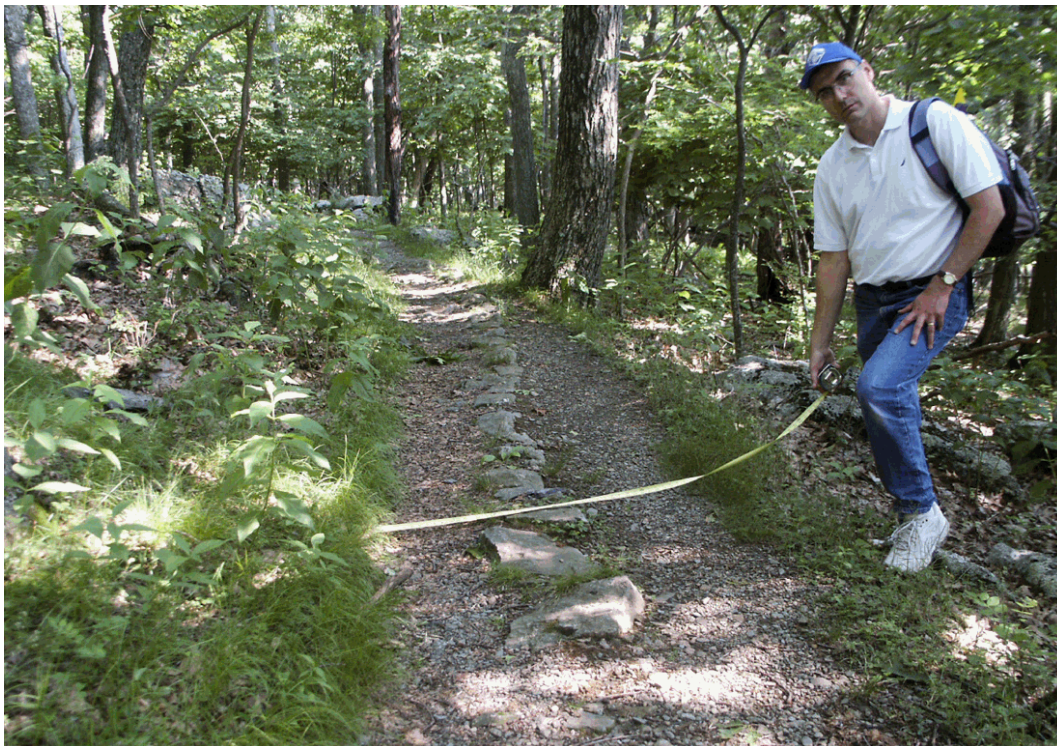
Figure 17: The CCC-graded trail has eroded and not retained the three-percent cross pitch. The trail has migrated and the stone edging that once supported the treadway now appears to bisect the trail. (SUNY, 2006)

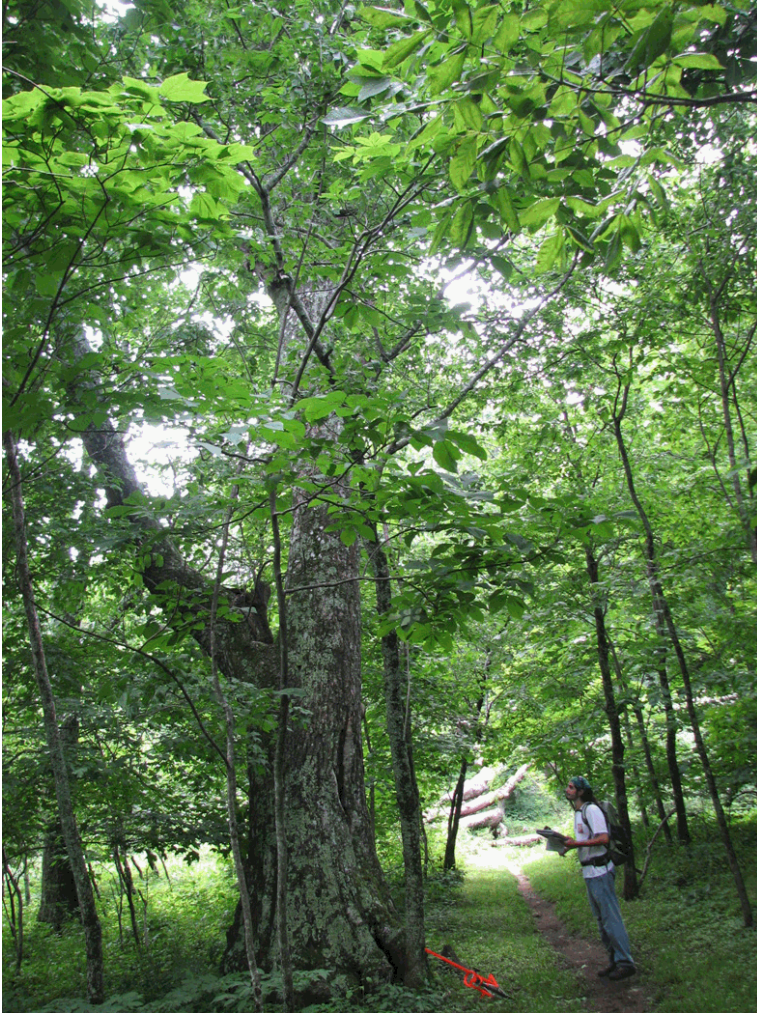
Figure 18: A large wolf tree along the AT near Bearfence Rock Scramble indicates its early development in on open field. Now the tree is surrounded by younger forest. (SUNY, 2006)

and height and contrast with the younger woods that surround them (Fig. 18). These ancient trees stand out along the trail corridor and recall the rich history of the park and the trail. Just north of Mary's Rock, the AT passes through a large mass of mountain laurel which was likely planted by the CCC (Route 421001).

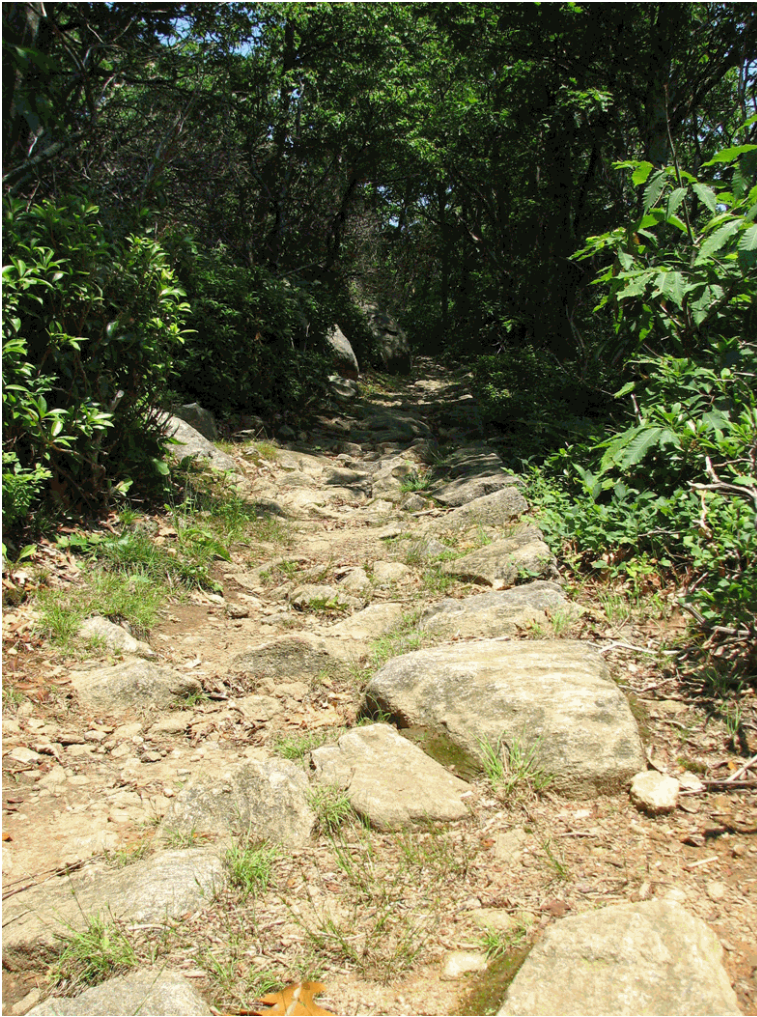
Figure 19: Stone edging still supports the treadway along the AT to Mary's Rock. The tread surface has lost its top-layered gravel courses. (SUNY, 2006)

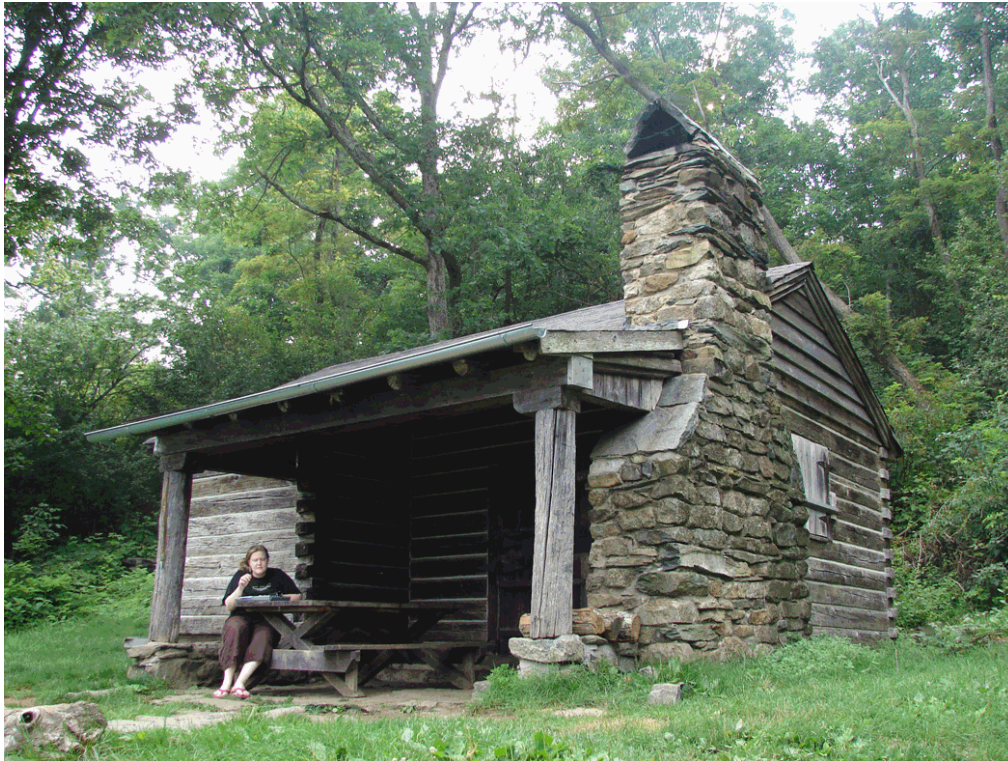
Figure 20: Pocosin Cabin was constructed by the CCC in 1937. It shows the NPS Rustic style of using local material and building techniques. The cabin can accommodate twelve hikers. (SUNY, 2006)

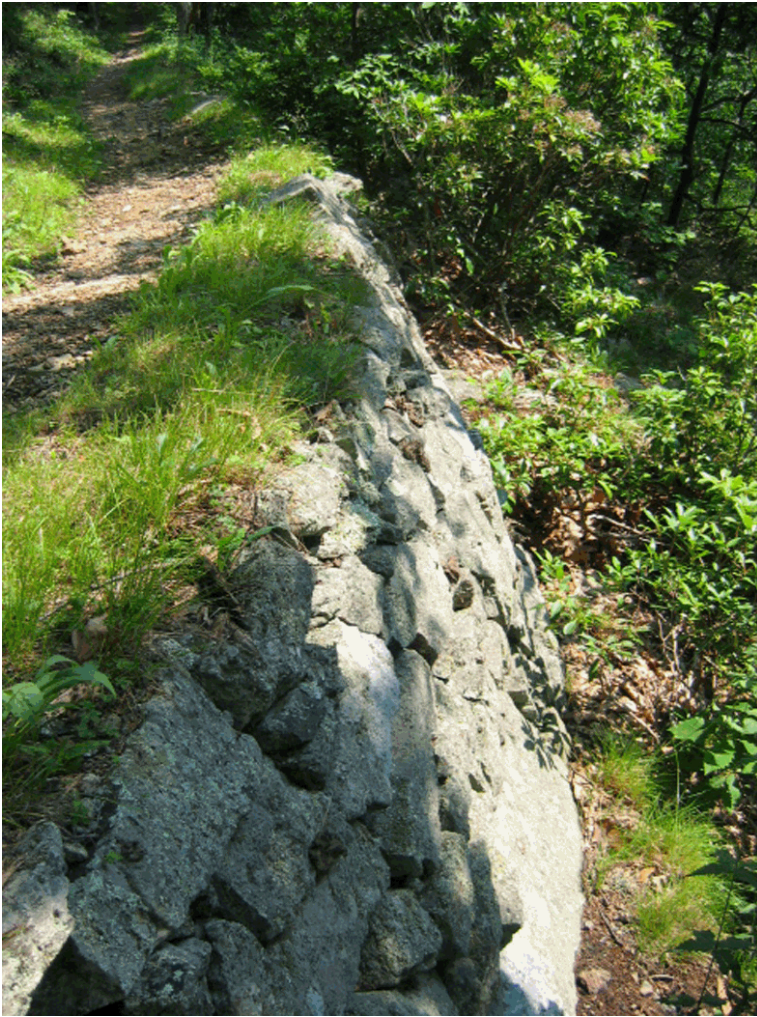
Figure 21: A CCC-built stone retaining wall supports the AT treadway near Spitler Knoll. (SUNY, 2006)

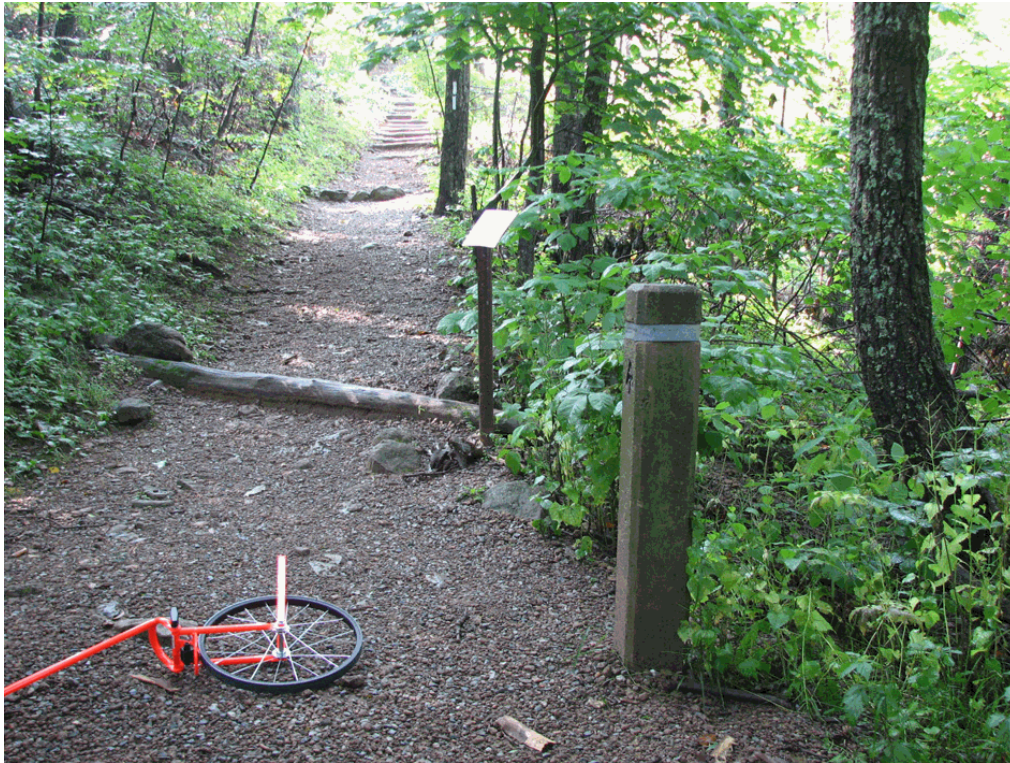
Figure 23: A historic concrete and zinc AT marker and a contemporary metal sign just beyond it at the beginning of the trail up to Mary's Rock. (SUNY, 2006)
